BRIDGE NO.: 104-1801 STRUCTURE INSPECTION REPORT

BRIDGE NAME: BELMONT BRIDGE

ROUTE NO.: ROUTE 20 / AVON STREET

Date of Inspection: 09/02/2010

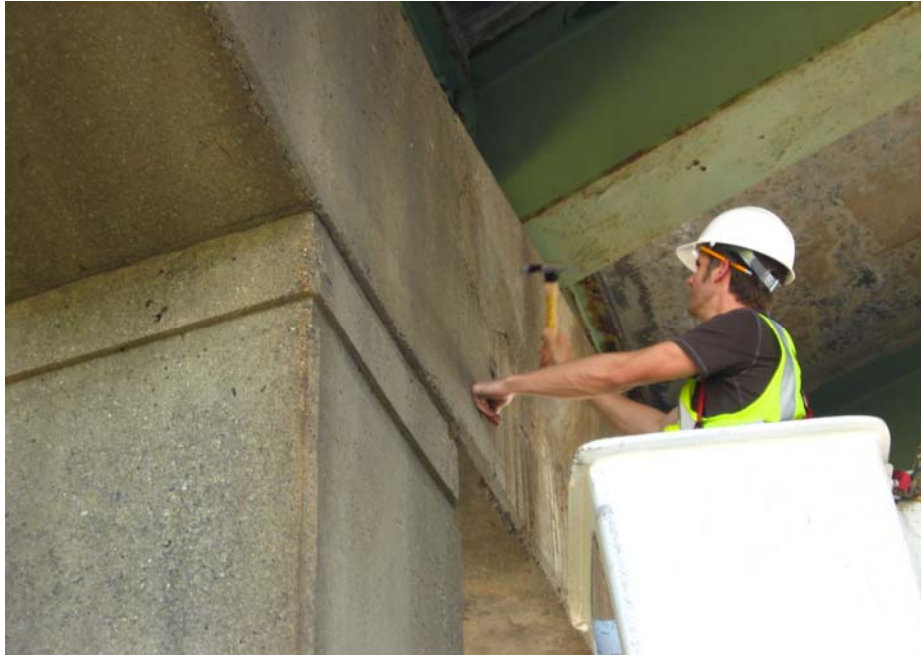
Photo #1

SPECIAL REQUIREMENTS (Special Equipment needed or Special Inspections required such as: Fracture Critical, Underwater, Fatigue Prone, Scour Critical, Moveable Bridge, Segmental Concrete, Pin and Hanger, etc.)	<p><u>Access Equipment</u> The superstructure was accessed with a bucket van. See Photo #1</p> <p><u>Fatigue Prone Details</u> This structure contains the following fatigue prone details Category D or higher:</p> <ul style="list-style-type: none"> • End welds along beam bottom flange cover plates. • Diaphragm connection plates welded to beams webs. <p><i>(Structure does not carry the required 500 trucks/day required for "hands-on" inspection.)</i></p> <p>See attached Fatigue Prone Detail Sheet for locations.</p>
WORK DONE	<ul style="list-style-type: none"> • Entire Deck has been covered with approximately 2" of new asphalt overlay.

MMM Inspector accessing Superstructure by means of a bucket van.

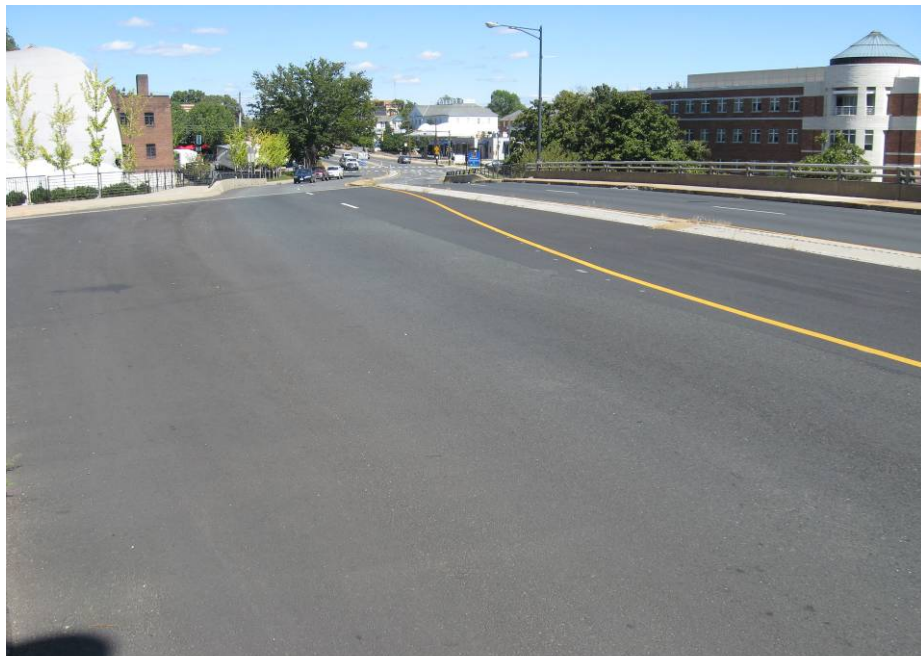
Photo #2

Looking north at SB traffic lanes. New 2" asphalt overlay has been applied.

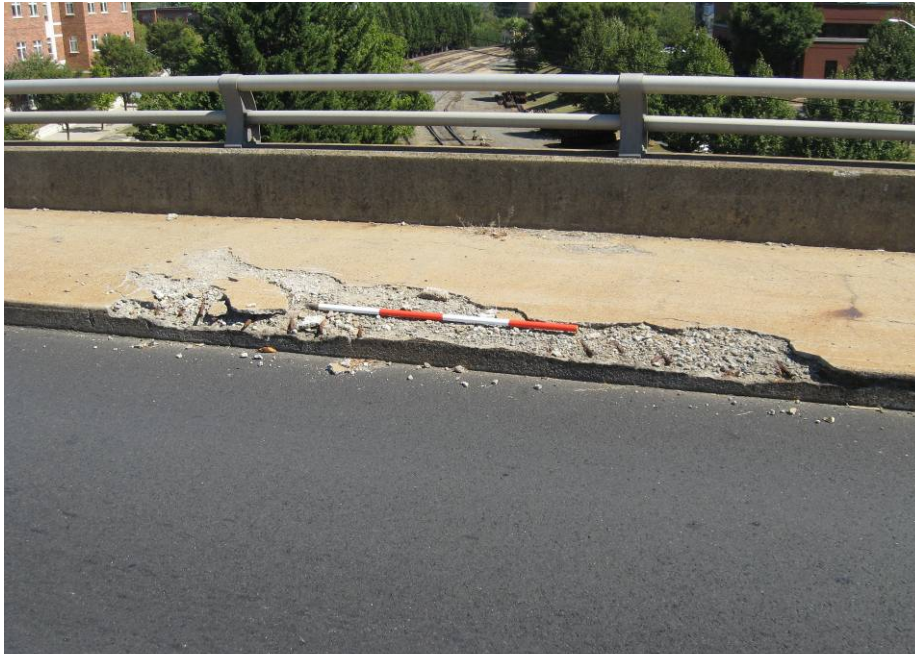
<p>See attached Component Detail Sheet.</p> <p><u>Curbs</u> Poor</p> <ul style="list-style-type: none"> • Heavy spalling and delamination over approximately 20 LF with exposed reinforcing in Span e of the northbound curb. See Photo #3 • Isolated areas of delamination and spalling noted throughout the remainder of the curbs. • Span B SB Lane 30 LF damaged curb (Patch failure) <p><u>Median</u> Fair</p> <ul style="list-style-type: none"> • Areas of cracking and spalling above the deck throughout and extensive wire reinforcing exposed and rusting below the deck. • Minor areas of vegetation growing along both sides of median at isolated locations. • 8 SF of median missing. See Photo #4 <p><u>Sidewalks</u> Poor</p> <ul style="list-style-type: none"> • Delamination, spalling, transverse cracking and areas of scaling (20-25%) with exposed reinforcing, primarily on the east (NBL) side. • Areas of previous patching at random locations throughout. • Minor areas of vegetation growing from sidewalk in spalled areas at isolated locations throughout. • Full depth spall 6" wide over pier 3, up to half width of sidewalk, rebar is exposed. See Photo #5 • Span E, 20 SF spalled concrete. Tripping hazard. • Settlement of sidewalk at Abutment A, up to 2" <p><u>Parapet</u> Good</p> <ul style="list-style-type: none"> • Minor areas of scale at isolated locations throughout. <p><u>Railing</u> Fair</p> <ul style="list-style-type: none"> • Areas of minor scale at isolated locations throughout. • Collision damage remnants SB rail Span E. See Photo #6 • Spall at railing along SB lane midpoint of span E; 4" diameter. <p><u>Lighting</u> Fair</p> <p><i>Span a, underside of deck</i></p> <ul style="list-style-type: none"> • Two light covers broken and filled with debris; both bulbs are out. Lack of illumination in Span A allows Abutment A to also be a dark area which could become a security issue allowing several dark areas adjacent to parking. <p><i>Span a, topside</i></p> <ul style="list-style-type: none"> • Electric cover at the base of light pole has only 1 bolt securing cover. <p><i>Span c, underside of deck</i></p> <ul style="list-style-type: none"> • West light operates on and off intermittently. <p><u>Utilities</u> Good</p> <p><i>Span f</i></p> <ul style="list-style-type: none"> • Utility support bracket is not attached and utility is sagging. <p><i>Security Camera</i></p> <ul style="list-style-type: none"> • Security camera added to one light pole on the east side of structure in Span E. • Light pole at abutment A along Northbound Traffic is completely missing access hatch at base of light pole and "hot" wires are visible. <p><u>Expansion Joints</u> Poor</p> <ul style="list-style-type: none"> • Joints are deteriorated full length typical throughout and recessed up to 5".

Looking east at curb along NB travel lane. Severe spalling and delamination damage to sidewalk poses danger to pedestrian and vehicular traffic.

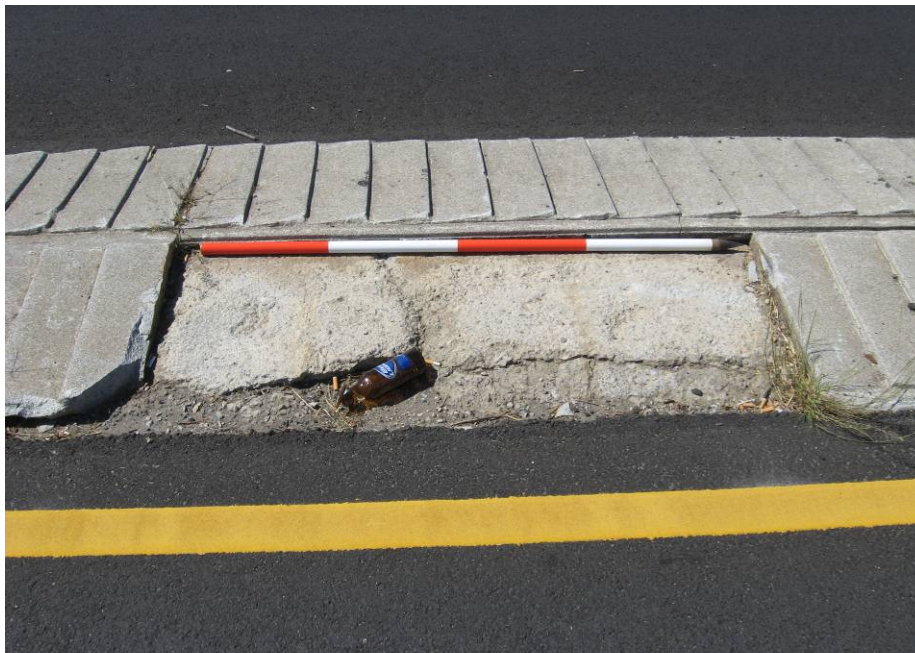
Photo #4

Looking west at median damage. Approximately 8 SF of median is has broken off.

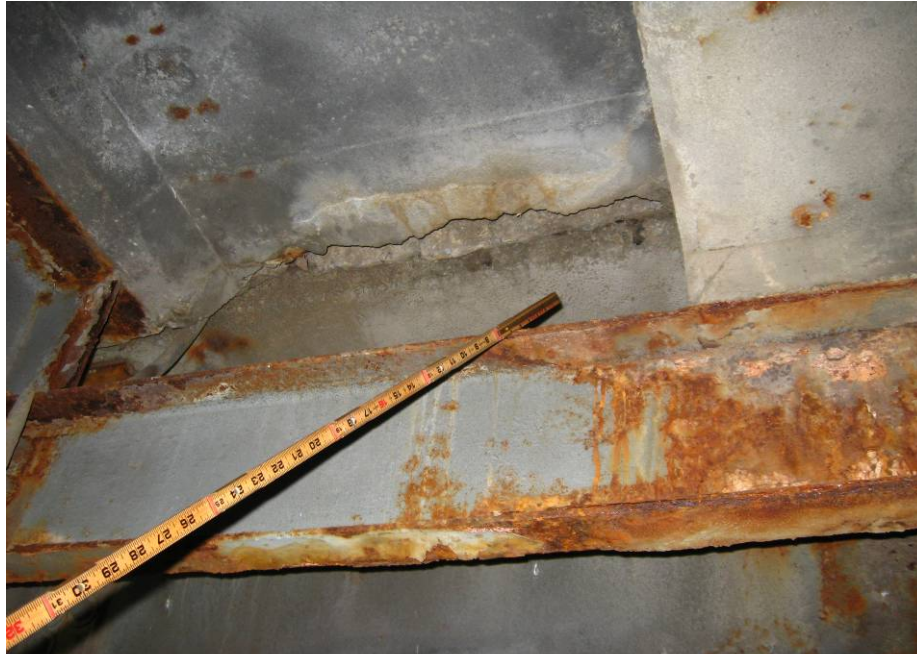
Photo #9

Looking at a typical diaphragm; showing heavy corrosion with minor to moderate section loss up to 1/8" due to leaking construction and expansion joints

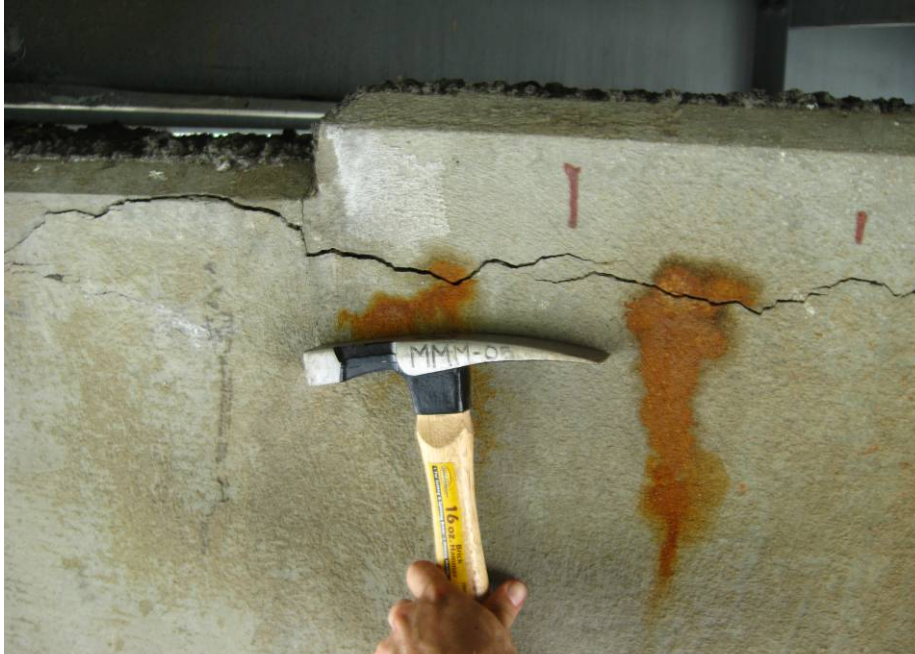
<p><u>Bearing Seats</u></p> <p><u>Walls</u></p> <p><u>Columns</u></p> <p><u>Footings</u></p> <p><u>Erosion/Scour/ Undermining</u></p> <p><u>Settlement</u></p>	<p>repaired; all delaminations and spalls chipped back to sound concrete and repaired. Repairs are sound. See Photo #10, #11</p> <p><i>Pier 3</i></p> <ul style="list-style-type: none"> • North Face 2 SF of delamination at repaired area under Beam 7. <p><i>Pier 4</i></p> <ul style="list-style-type: none"> • South face under Beam 9; Spall 18"x4" long with exposed rebar (previously noted as: 6 SF of delamination.) • Bay 9 horizontal crack 1/8" wide x 6' long. Spall 18"x4' long (south face) • Utility lines in front of cap prevent close-up inspection. • Below beam #2 crack & delamination on south face • Below Beam #11; spall 12" wide x 18" high with exposed rebar (south face) • Below Beam #12; spall 12" wide x 12" high with exposed rebar (north face) • Below Beam #11 1' diameter spall x 1" deep, 4 SF delamination <p><i>Pier 5</i></p> <ul style="list-style-type: none"> • Cracks up to 1/8" up to 3' long and areas of delamination throughout. <p><i>Pier 6</i></p> <ul style="list-style-type: none"> • Bay 10; 3 SF spall, excessive debris due to failed expansion joint material • Bay 4; 1 SF delamination <p>Fair</p> <ul style="list-style-type: none"> • Minor areas of debris accumulation at isolated locations. • Previous areas of spall have been repaired. • Cracks up to 1/8" present. See Photo #11 <p>Good</p> <ul style="list-style-type: none"> • Minor hairline to 1/32" wide vertical cracks along the crash wall. <p>Good</p> <ul style="list-style-type: none"> • No noteworthy deficiencies. <p><i>Not Visible. No indication of poor performance.</i></p> <p>Good</p> <ul style="list-style-type: none"> • No noteworthy deficiencies. <p>Good</p> <ul style="list-style-type: none"> • No noteworthy deficiencies.

Looking at a pier cap below a beam bearing; cracking and rust staining throughout pier caps.

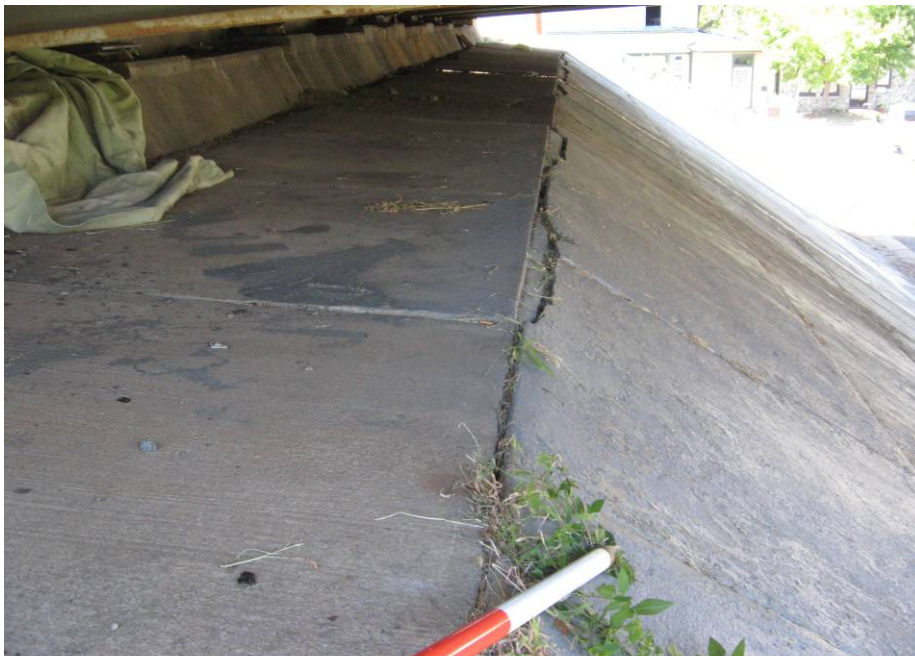
Photo #12

Looking west at Abutment A settlement; Full length separation crack at top of slope protection
